# Manhole Inspection Summary

Manhole # S21K1\_019MH

**Location** Address: **2551 marbourne av**

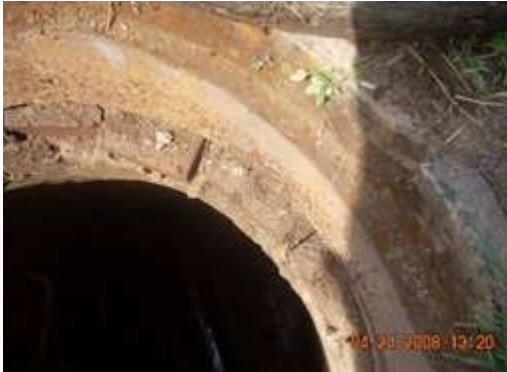
Defect 1

**Frame** Offset: **1** (in.) Condition: ☒ Sound ☐ Cracked ☐ Leaks

frame offset

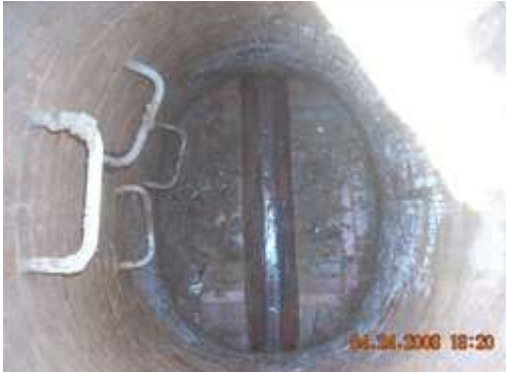
Defect 2

**Steps** Count: **4** Missing: **0** ☒ Corroded

corroded syeps

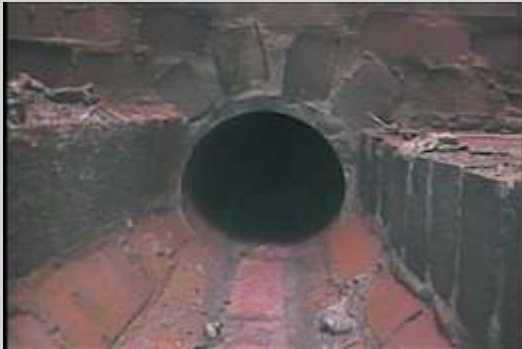
12 O'Clock Outflow

Pipe Height: **8.4** (in.) Rod and Bar (Angled)  
Pipe Material: **Clay** ☐ Pipe Lined  
Invert Depth: **8.64** (ft.) Flow Characteristics: **None**  
Deposits: ☒ None ☐ Mud ☐ Sludge ☐ Debris ☐ Grease  
Silt Depth: **0** (in.) Deposits Extent:  
Infiltration: **None** Pipe Seal Cond: **Sound**

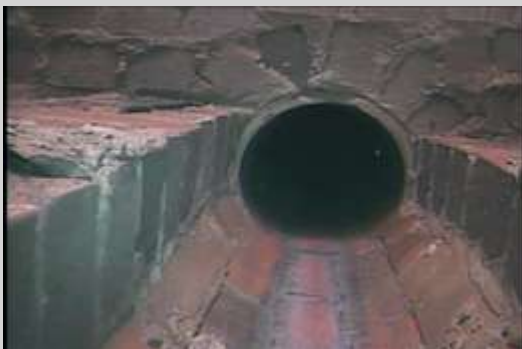
6 O'Clock Inflow

Pipe Height: **8.4** (in.) Rod and Bar (Angled)  
Pipe Material: **Clay** ☐ Pipe Lined  
Invert Depth: **8.34** (ft.) Flow Characteristics: **None**  
Deposits: ☒ None ☐ Mud ☐ Sludge ☐ Debris ☐ Grease  
Silt Depth: **0** (in.) Deposits Extent:  
Infiltration: **None** Pipe Seal Cond: **Sound**
